Manhole Inspection Summary

Manhole # S23AA1004MH

Insp Date: **6/25/07 2:44 PM**

Location Address: **3519 ASH ST**

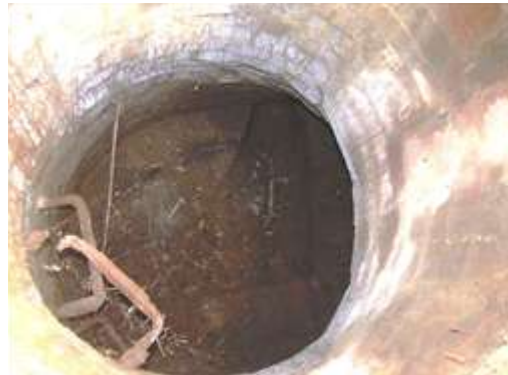
Top View

Corroded steps. Bench and Channel debris.

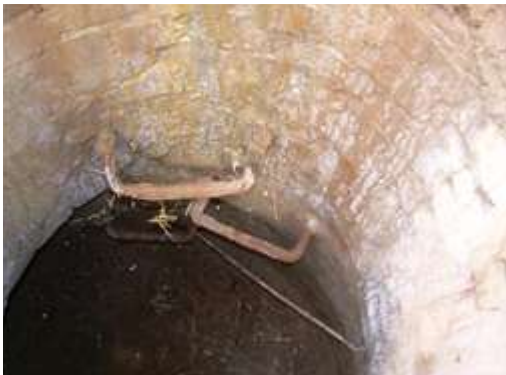
Defect

Adjustment and Barrel infiltration.

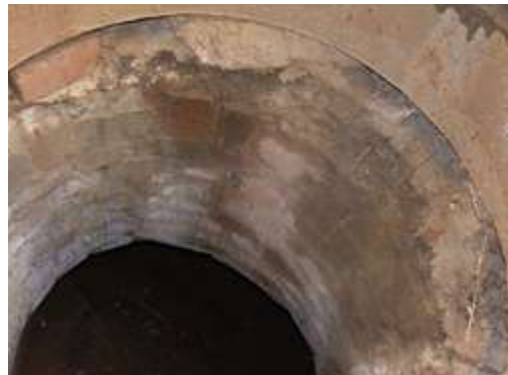
Defect

Frame leaks. Adjustment deterioration, loose brick, root intrusion and infiltration.

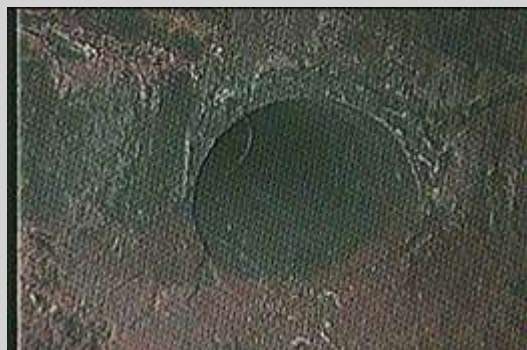
Pipe Out @ 12 O'Clock

8 in. Circular Gravity Sewer

Deposits: ☐ None ☒ **Mud** ☐ Sludge ☒ **Debris** ☐ Grease

Infiltration: **Evidence**

Pipe Seal Cond: **Cracked**
